IRC 11089-MB10-165CR

St. David and St. Patrick Anglican Church
520 Speedvale Road East
Guelph, Ontario
N1E 1P6

RE: Flat Roof Retrofit Feasibility Study
St. David and St. Patrick Anglican Church

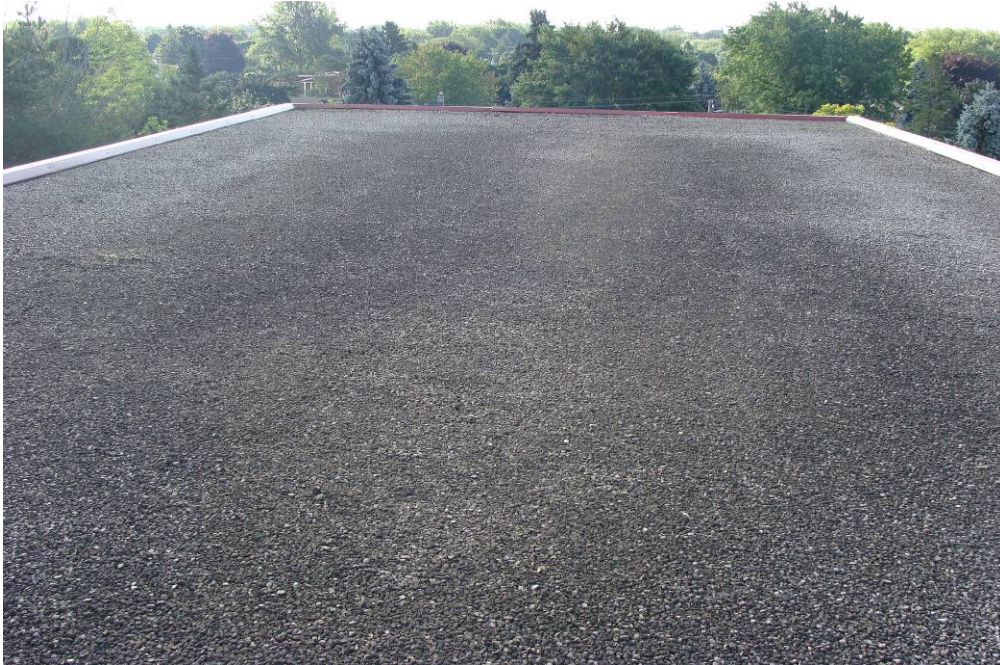
1. The main hall roof system is a multiple ply, felt and asphalt, built up roof membrane assembly with pea gravel surfacing (Photograph 1). According to the cut test, there is a 1.5" thick layer of fibreglass insulation (Photograph 2). This roof has an approximate R-value of 7. At the core sample, the membrane felts were noted to be deteriorated. It appears that repairs have been completed recently at the south perimeter of the roof area (Photograph 3). This corresponds with comments made by Mr. Kupp, that there have been ongoing leaks at over the alter area at the south end of the main hall. The roof area is drained by 3 perimeter scupper; one at the southeast corner, one at the northwest corner and one at the mid point of the north side (Photograph 4). Deflection of the roof structure has resulted in ponding water in the centre of the roof area. This roof is at or near the end of its useful service life.

Photograph 1: View of the main roof area. The dark areas in the gravel surfacing indicate areas of ponding water.

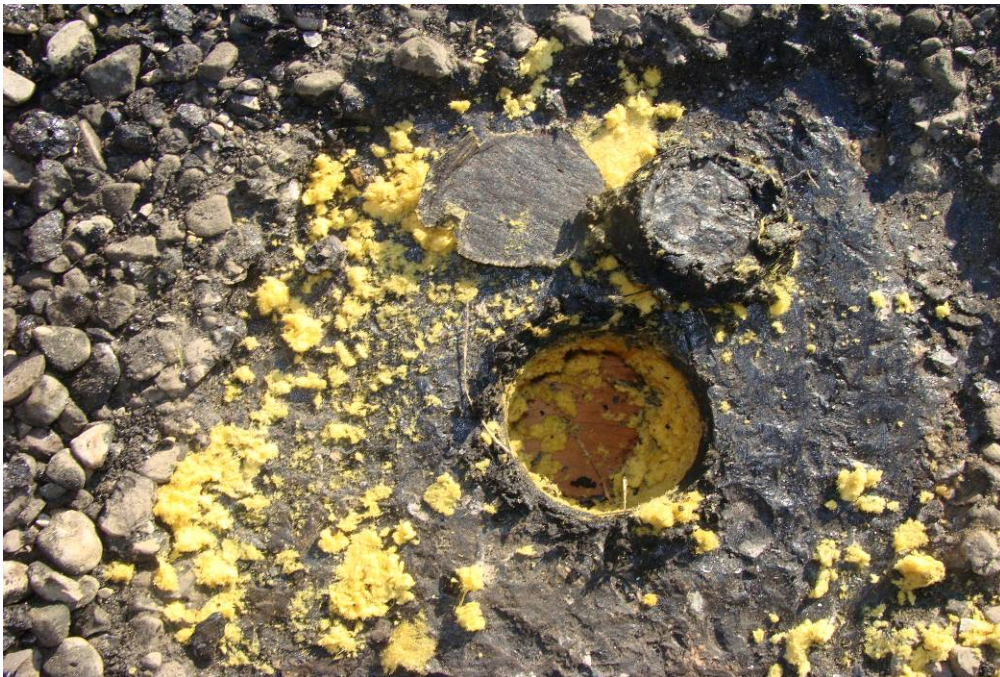
Photograph 2: View of the core cut at the main roof area.

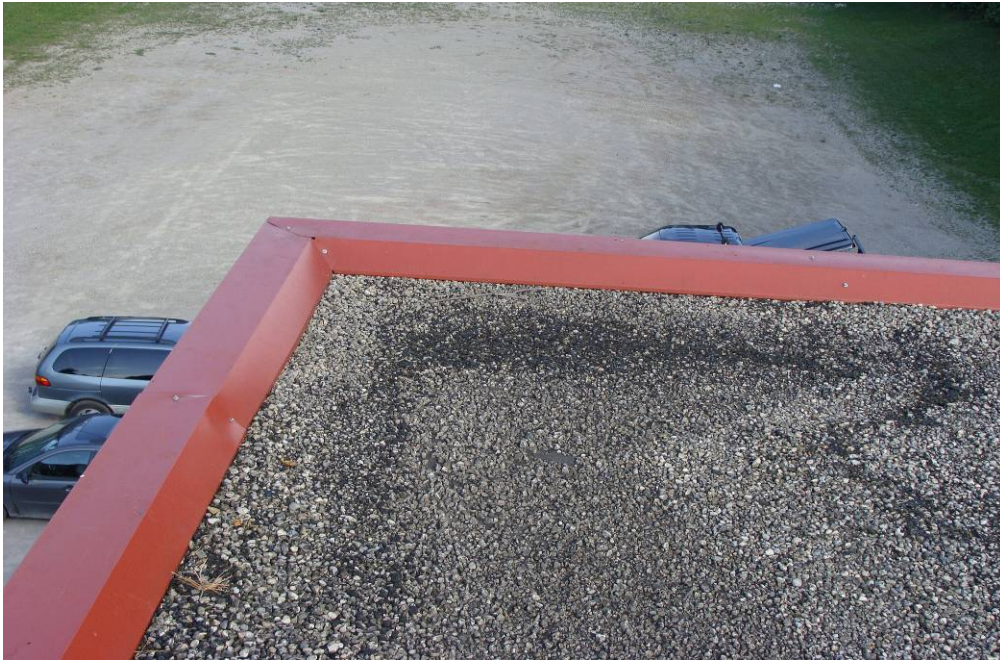
Photograph 3: Scouring at the corner of the roof area, exposing the membrane.

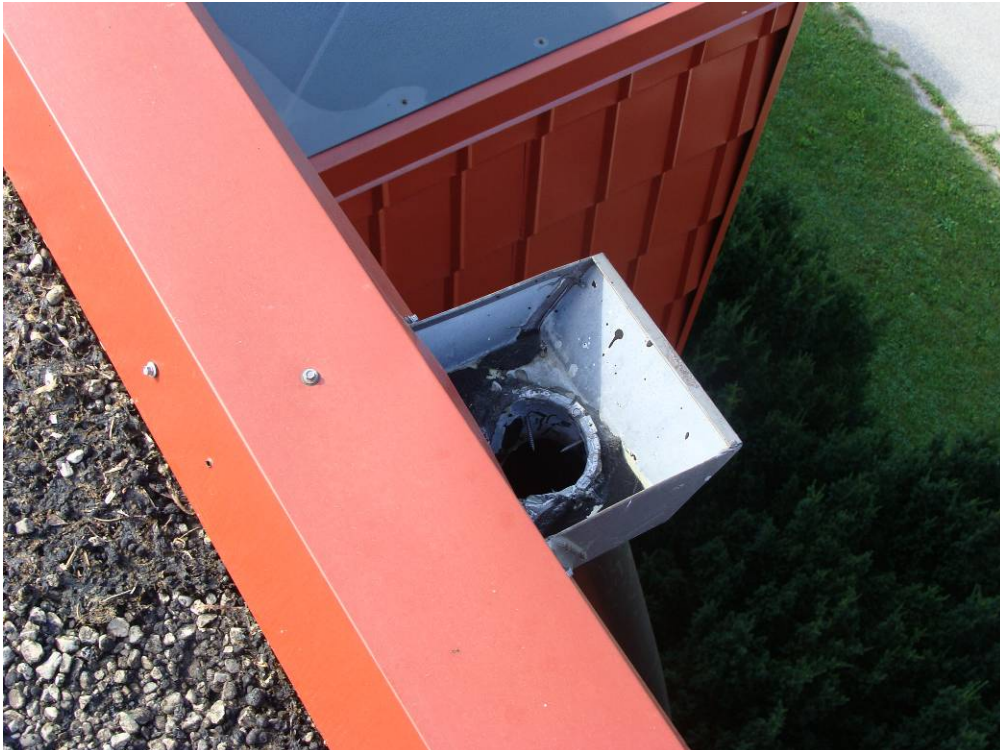
Photograph 4: View of a typical scupper drain.

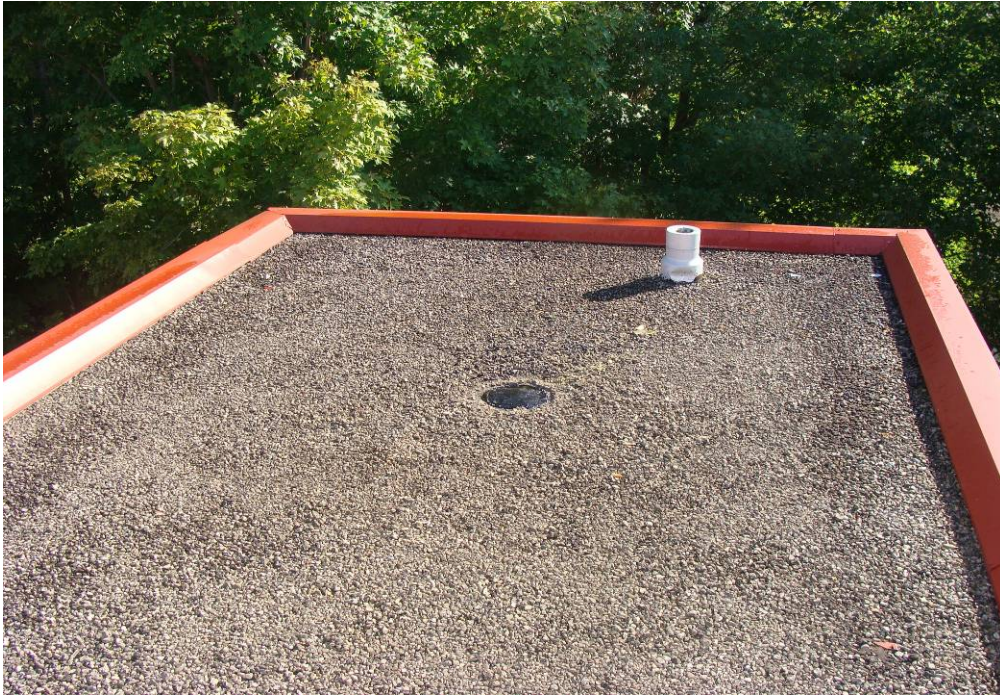
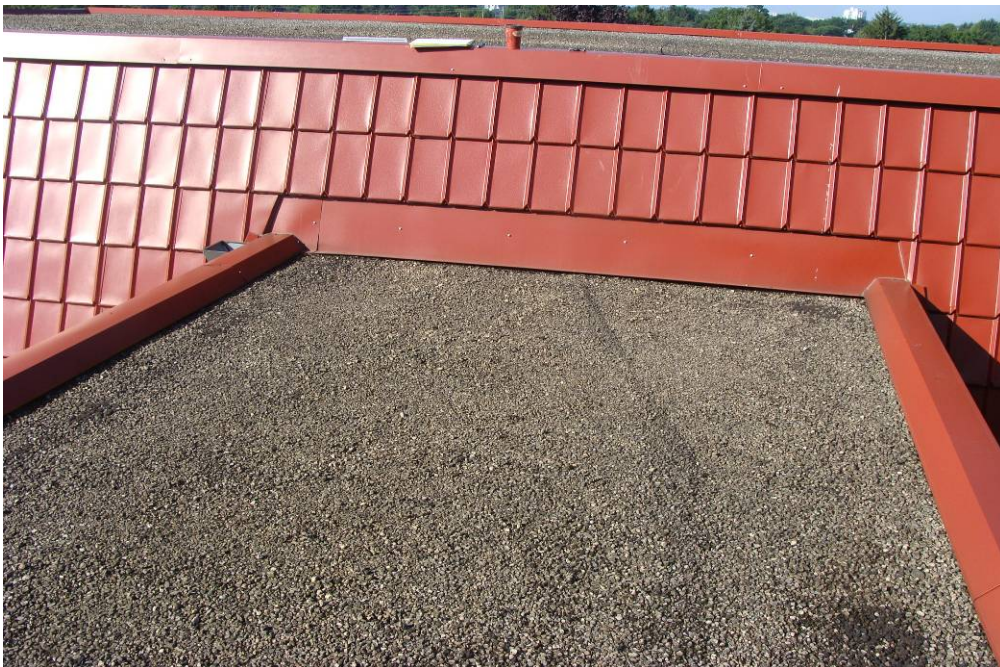
2. The roof system at the bump out on the east elevation of the main hall (Sacristy/Choir Area) has the same roof assembly as the main roof (Photographs 5 and 6). This roof is drained by a single scupper that drains down over the metal tile system at the mansard wall below, no downspout has been provided. This roof is at or near the end of its useful service life.

Photographs 5 and 6: View of the sacristy/choir area roof.

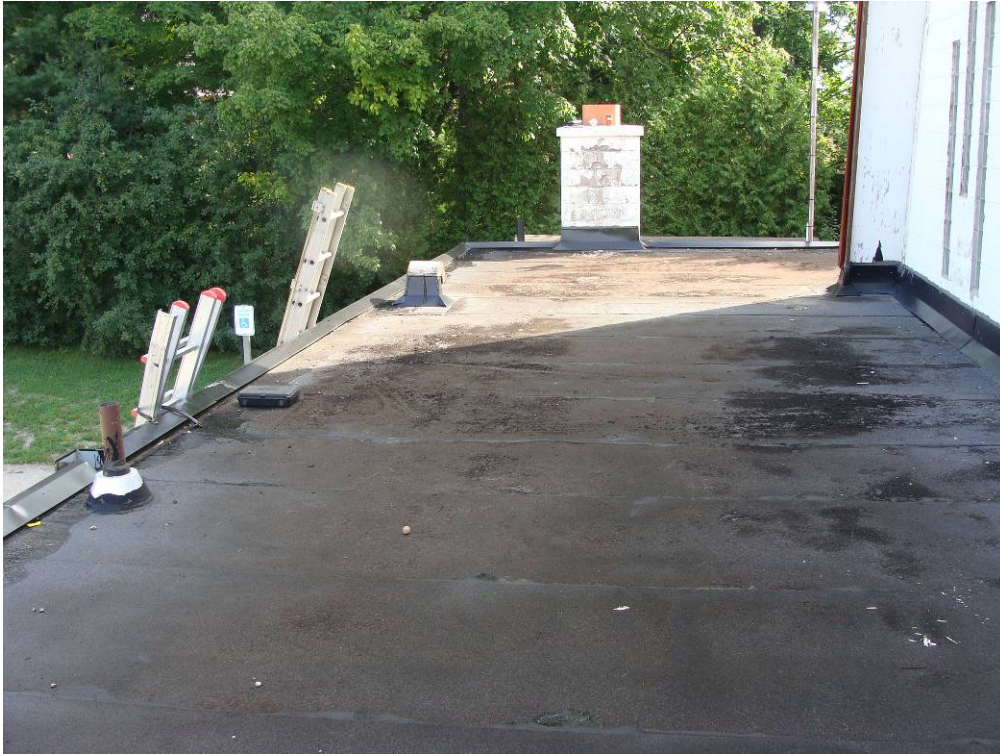
3. At the lower roof area over the foyer/study area at the rear of the building, the roof membrane system is a 2 ply modified bitumen membrane system (Photograph 7). The core test indicates that the roof assembly below the membrane includes a ½" layer of fibreboard over 3" of polyisocyanurate insulation, over a 2 ply asphalt and felt vapour retarder. This roof has an approximate R-value of 20. The roof is drained by 2 scuppers along the north side. The roof generally appeared to be in fair condition. According to information supplied to IRC, this roof was completed at the same time as the mansard roofs, approximately 13 years ago. The roof does not appear to drain very well. It appears that repairs have been completed in the form of hot pour asphalt at the perimeter flashing (Photograph 8). This roof has approximately 3 to 5 years of service life remaining.

Photograph 7: View of the low roof area over the entrance foyer.

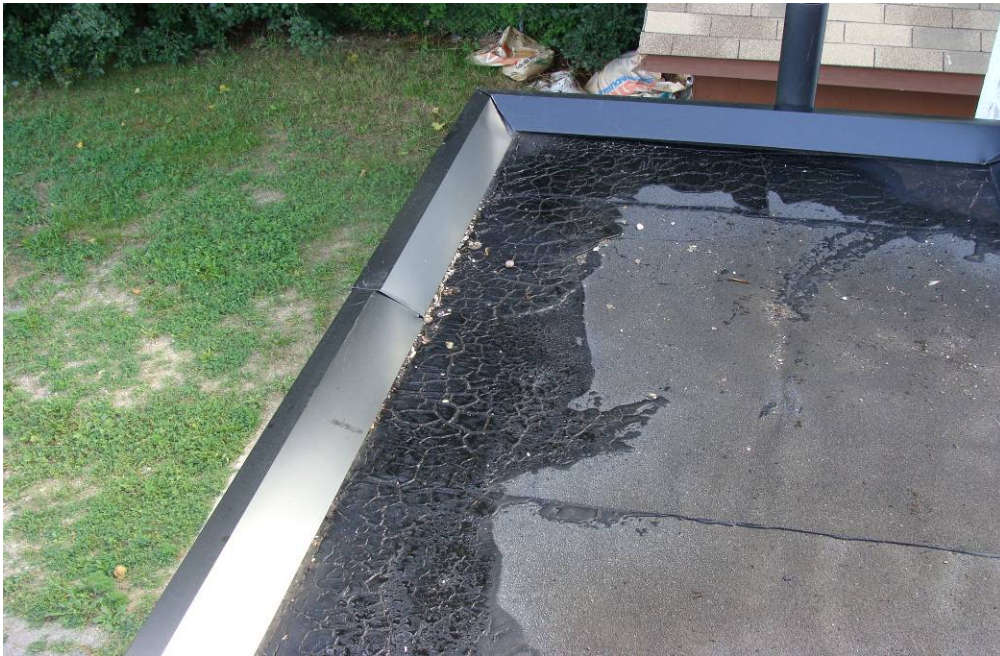
Photograph 8: View of the hot pour asphalt repairs at the low roof area.
